NACA TN 3775

TECHNICAL NOTE 3775

CRASH INJURY

By Gerard J. Pesman and A. Martin Eiband

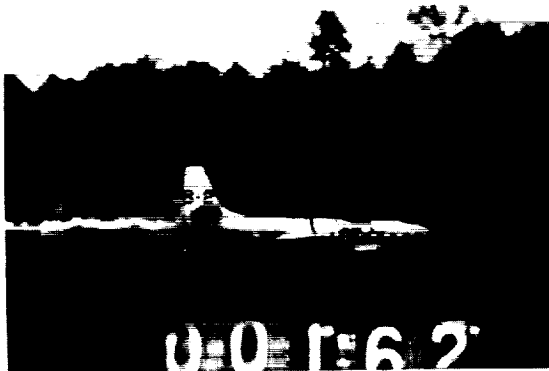
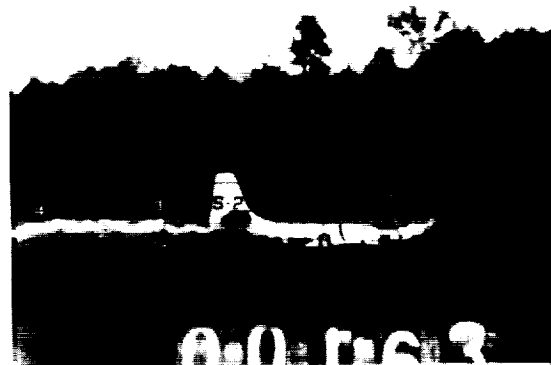
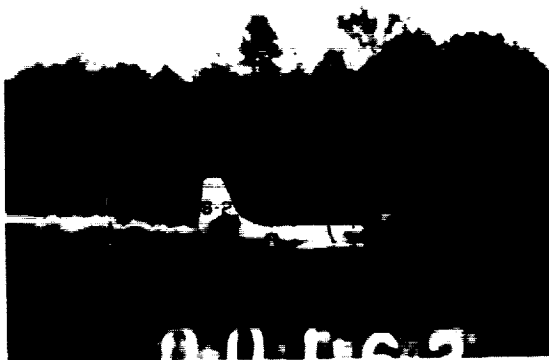
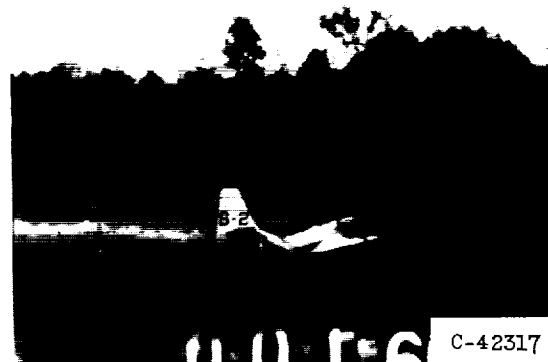
Figure 1. - Crushing of nose and cockpit structure in fighter airplane crash.

the airplane's trajectory and the ground surface). The airplane speed at the instant of impact was about 110 miles per hour. The photographs of figure 1, reproduced from a motion picture of the incident, show a succession of steps in the crushing action. Figures 1(a) to (c) show that the fuselage structure was not strong enough to noticeably deflect the airplane from its original path; the fuselage crushed continuously. When the stronger wing and engine support structure struck the ground (fig. 1(d)), the airplane's path was changed until the airplane was moving parallel to the ground and the crushing action stopped. By that time, however, every part of the fuselage structure ahead of the wing, including the cockpit, had been crushed. If the angle of impact and impact speed are great enough, any airplane will crush in a similar manner. Survival under such circumstances is improbable.

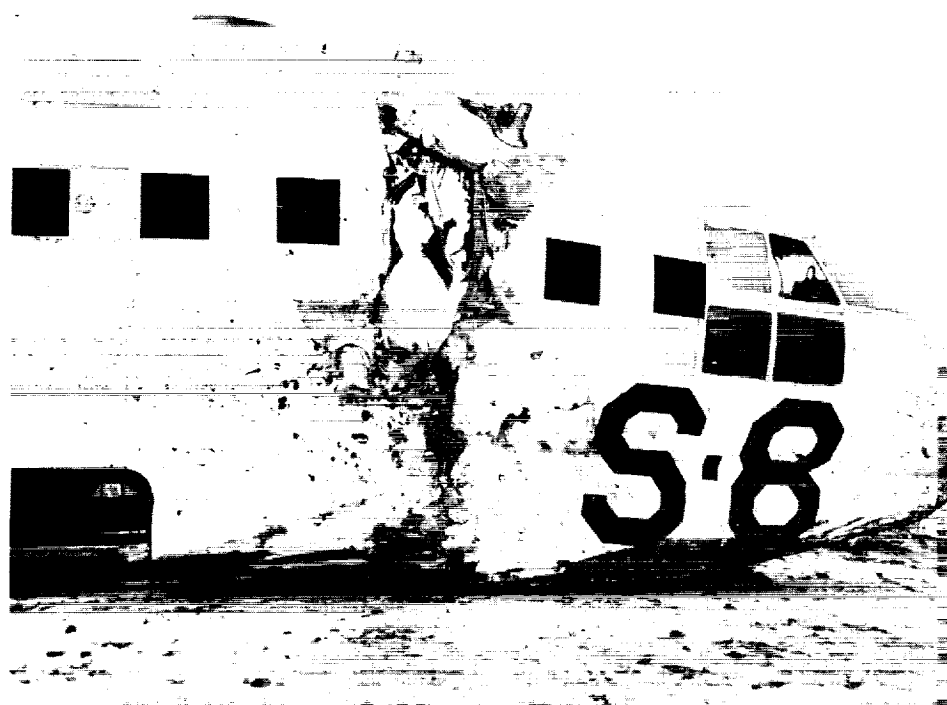
Figure 16. - Hole cut in fuselage by propeller blades.

Propeller blades and fragments of blades that are broken off when propellers strike an obstacle can appear as missiles inside the airplane. The action of steel propeller blades is shown by the photographs in figure 15. Three propeller blades were detached from the propeller hub (fig. 15(b)) and cut through the fuselage (fig. 15(c)). They can be seen against the sky in figure 15(d). An indication of the damage such missiles can do can be gained from figure 16, which shows the holes cut in the fuselage walls. Each opening is about 1 foot wide and 4 feet high.

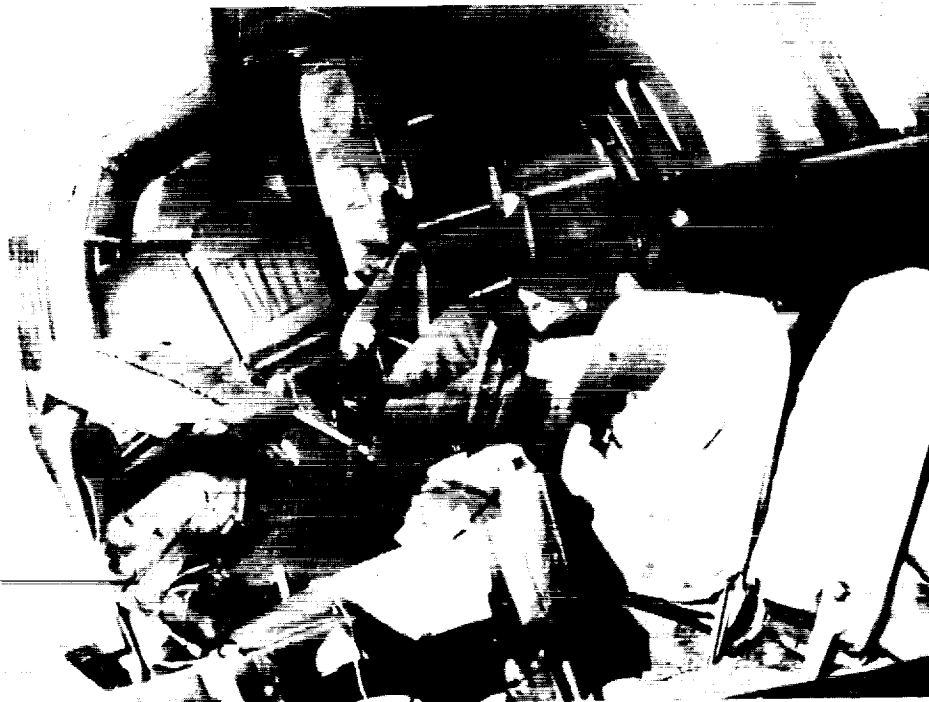
Figure 21. - Failed seats torn loose and piled in front of cabin.

If seat belts fail, or if the seats break loose, then the occupants instead of flailing about become free bodies inside the airplane. When this happens, passengers pile up in the front of the cabin. Figure 21 shows seats piled in the front of an airplane after the passengers were removed.

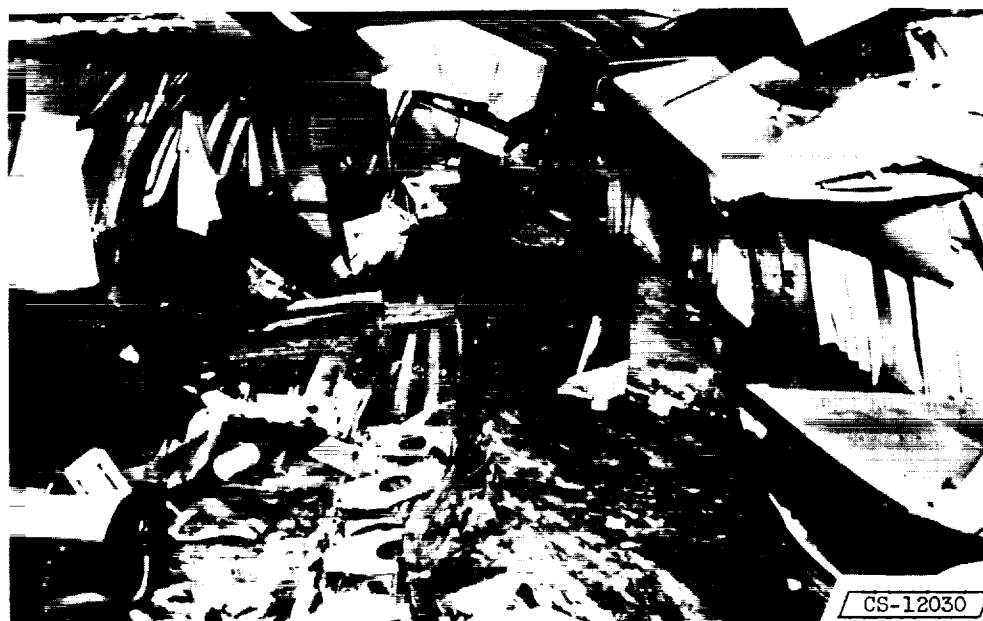
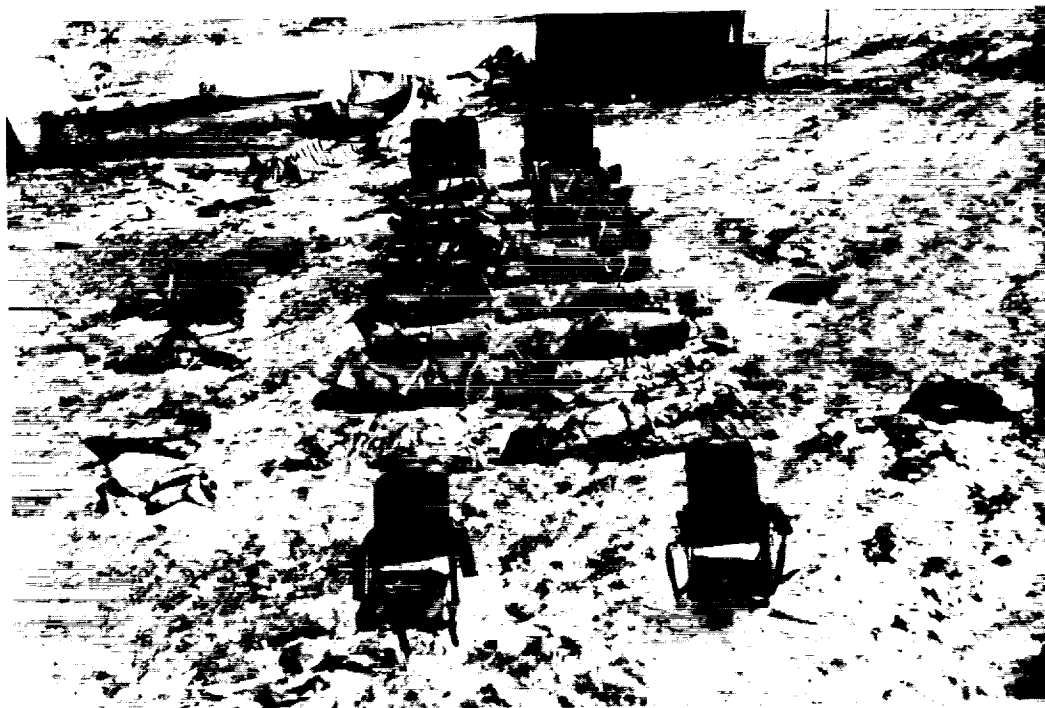
Figure 22. - Crash in which impact forces destroyed seat attachment fittings. (Photographs supplied by Aviation Crash Injury group of Cornell University.)

(c) Seat wreckage assembled in original rows.

Wreckage from another accident in which many seats pulled loose is shown in figure 22. Broken seats could have been expected in front of the break in the fuselage (fig. 22(a)) because the fuselage structure was severely damaged. Aft of the break, however, the fuselage structure did not appear severely damaged, and little seat damage would have been expected. After the debris had been removed, the cabin appeared as shown in figure 22(b). The floor was badly deformed, and all the passengers' seats except the aft four had come loose (fig. 22(c)).

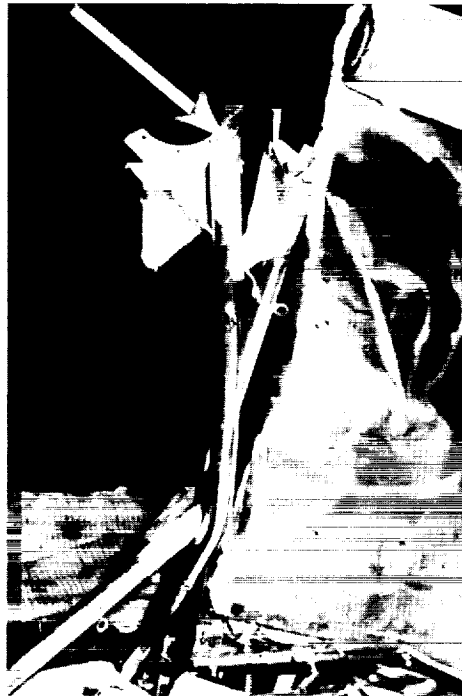
Figure 23. - Spear-like point formed by broken seat back tubing.
(Photograph supplied by Aviation Crash Injury group of Cornell University.)

When people and seats are torn loose and become free bodies in a sliding hulk, they can strike sharp, pointed, or solid obstacles. Broken seat parts are examples of obstacles that can cut and puncture people as they are thrown about. An example of such a spear, a broken tube from the seat back, is shown in figure 23. A similar spear in the same
